# ADM guidance—Ceramics: guidance to the use of fractography in failure analysis of brittle materials

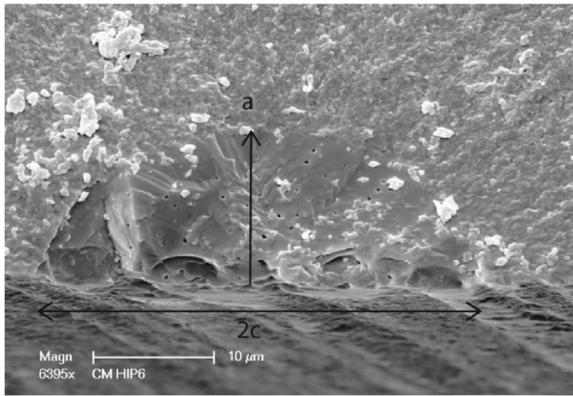
The well delineated fracture origin in Fig. 7 has a peculiar microstructure that differs from the bulk microstructure and corresponds to excessive grain growth. This is due to a localized concentration of 2.8 wt% of CaO used as a sintering catalyst and was detected by energy dispersive X-ray spectroscopy (EDX). This flaw, made of large grains, was the fracture origin and was responsible for the low fracture stress (680 MPa) in this 4-point bending fractured bend bar specimen. The critical flaw ( $a$ ) measured 13  $\mu\text{m}$  deep and 37  $\mu\text{m}$  wide ( $2c$ ). The calculated critical stress intensity shape factor  $Y_{\text{depth}}$  is

1.4 using solutions from Scherrer et al. [48]. Hence, the resulting fracture toughness using Eq. (1) would be in this case only  $3.4 \text{ MPa}\sqrt{\text{m}}$  which is rather low compared to the usual value of approximately  $4.5\text{--}5 \text{ MPa}\sqrt{\text{m}}$  reported for 3Y-TZP.

**Fig. 7 – Fracture origin in a 3Y-TZP bend bar fractured in 4 point-bending. The critical flaw has a crack depth (a) = 13  $\mu\text{m}$ , a crack width (2c) = 37  $\mu\text{m}$ , a fracture stress ( $\sigma_f$ ) = 680 MPa and a calculated critical intensity shape factor  $Y_{\text{depth}} = 1.4$  using Scherrer et al. [48]. Hence, the estimated fracture toughness in this case would be  $K_{Ic} = 3.4 \text{ MPa}\sqrt{\text{m}}$  (data from Ref. [35]).**

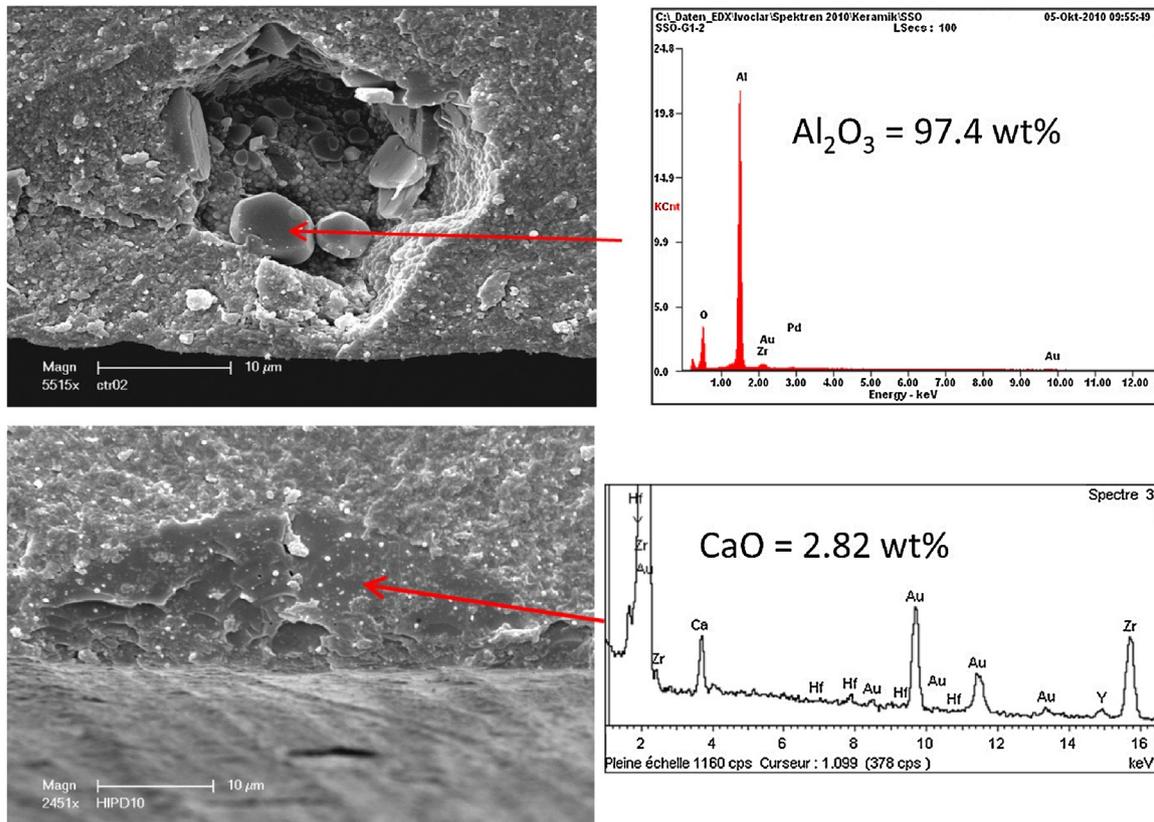
The problem of contamination or detrimental chemical additives involved with the failure origin is illustrated in Fig. 9 to which EDX was added. Two failure origins from strength testing are documented in 3Y-TZP bend bars. The first one is a large pore at the failure site containing alumina particles, possibly from powder contamination. The second is a flaw containing a concentration of 2.8 wt% CaO, which contributed to localized grain growth, weakening the zirconia and from which the crack started (data from Ref. [35]).

**Fig. 9 – Failure origins in 3Y-TZP bend bars. EDX combined with SEM allows identification of contaminants composition. The top image shows alumina particles inside a pore within a critical flaw (a  $20 \times 30 \mu\text{m}$ ) connected with the tensile surface. The bottom image shows a critical flaw of  $14 \mu\text{m}$  in depth containing 2.82 wt% CaO responsible for grain growth. Recommendation 3: When identified fracture origins show problems such as inclusions, second phase grains, contaminations or abnormal grain growth, a chemical spectral analysis should be performed within the critical flaw (Fig. 9) for feed-back in relation to processing issues. When possible, make use of the backscattering mode to better visualize the critical flaw (Fig. 8).**

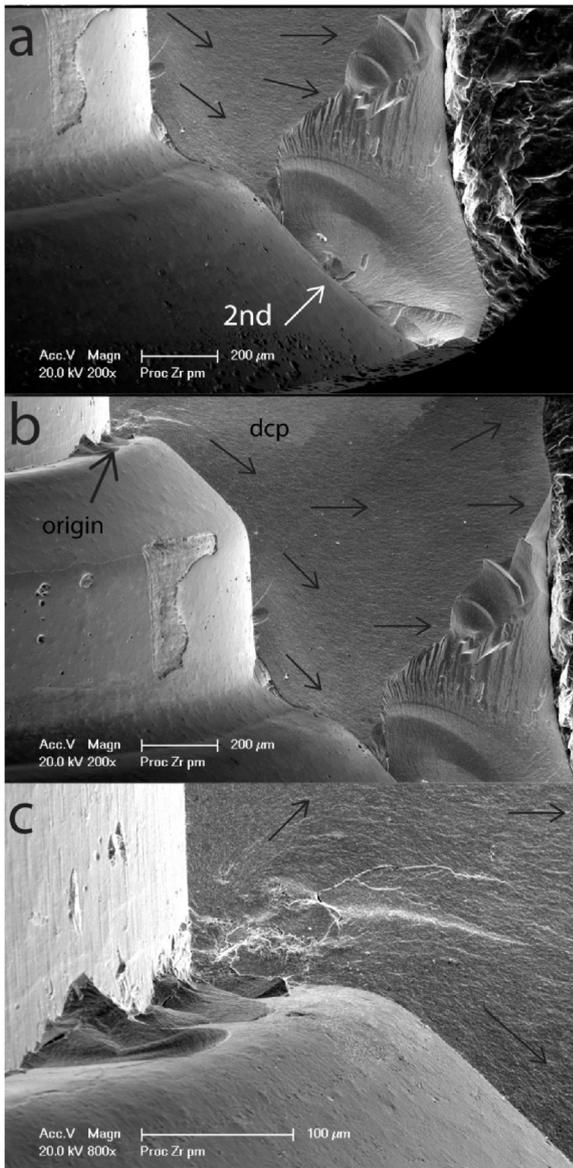
**Fig. 10 – Fracture of a veneered zirconia abutment screwed onto a titanium implant. Fracture occurred after two years of intra-oral use. (a) shows a secondary chip fracture at the shoulder level which should not be confused with the fracture origin seen in (b) and (c). If only (a) is shown in a paper claiming this chip-fracture to be the origin of the critical fracture of the abutment-crown, then an erroneous message will be delivered. On the same image a more expert understanding of the fracture surface and its interpretation will recognize the presence of small hackle indicating the prime direction of crack propagation (dcp, black arrows). (b) and (c) show the correct origin of the critical crack located at the corner. A major twist hackle is emanating from it rotating outwards. Further fractographic documentation of this case is provided in Figs. 11 and 12.**

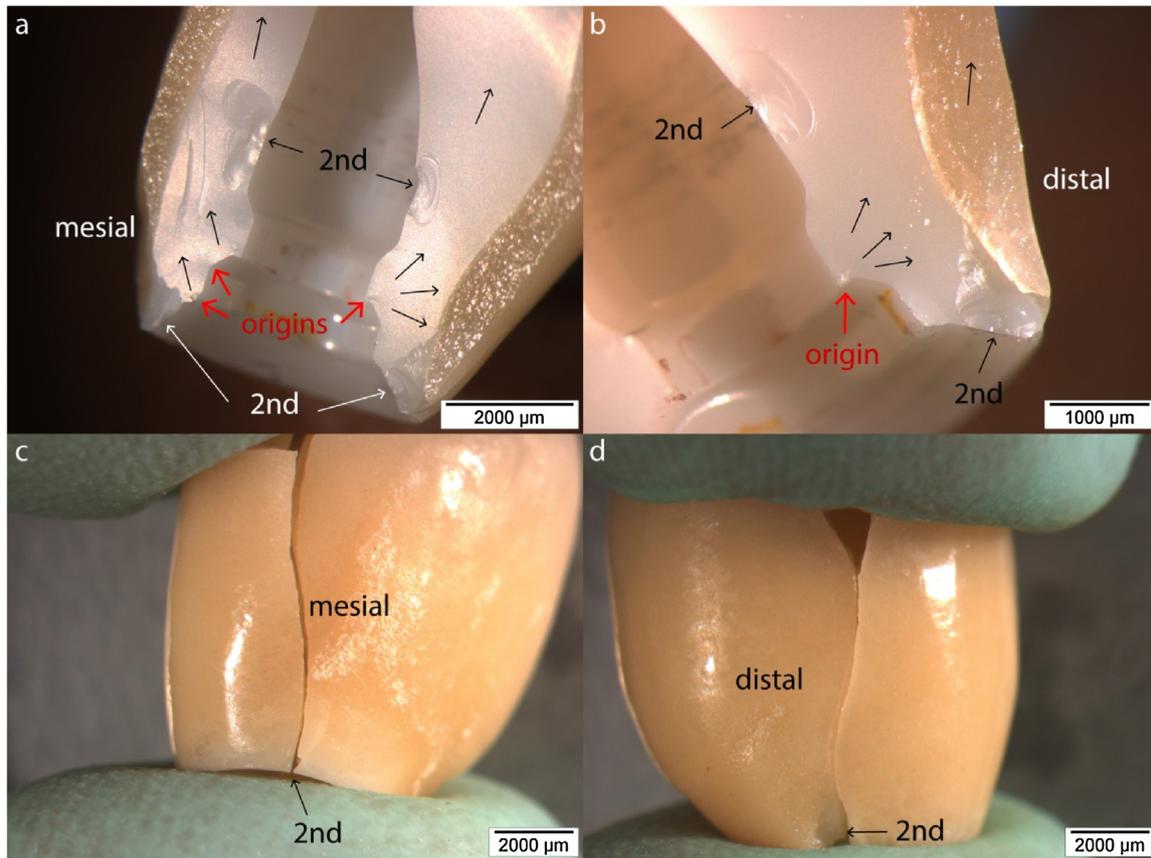
**Fig. 11 – Procera zirconia abutment directly veneered for crown restoration screwed onto a Titanium implant. Fracture occurred after 2.5 years in-situ. Matching halves are joined together with some material loss visible at both margins (mesial and distal). Failure origins are marked with red arrows. The crack propagation direction is marked with black arrows. Secondary events (2nd) are visible at the margins (loss of material) as well as at the level of the screw head contact showing starter cracks from the inside towards the outside on both sides but confined to the zirconia framework (more failure analysis of this case in Fig. 12) (For interpretation of the references to color in this figure legend, the reader is referred to the web version of this article.)**

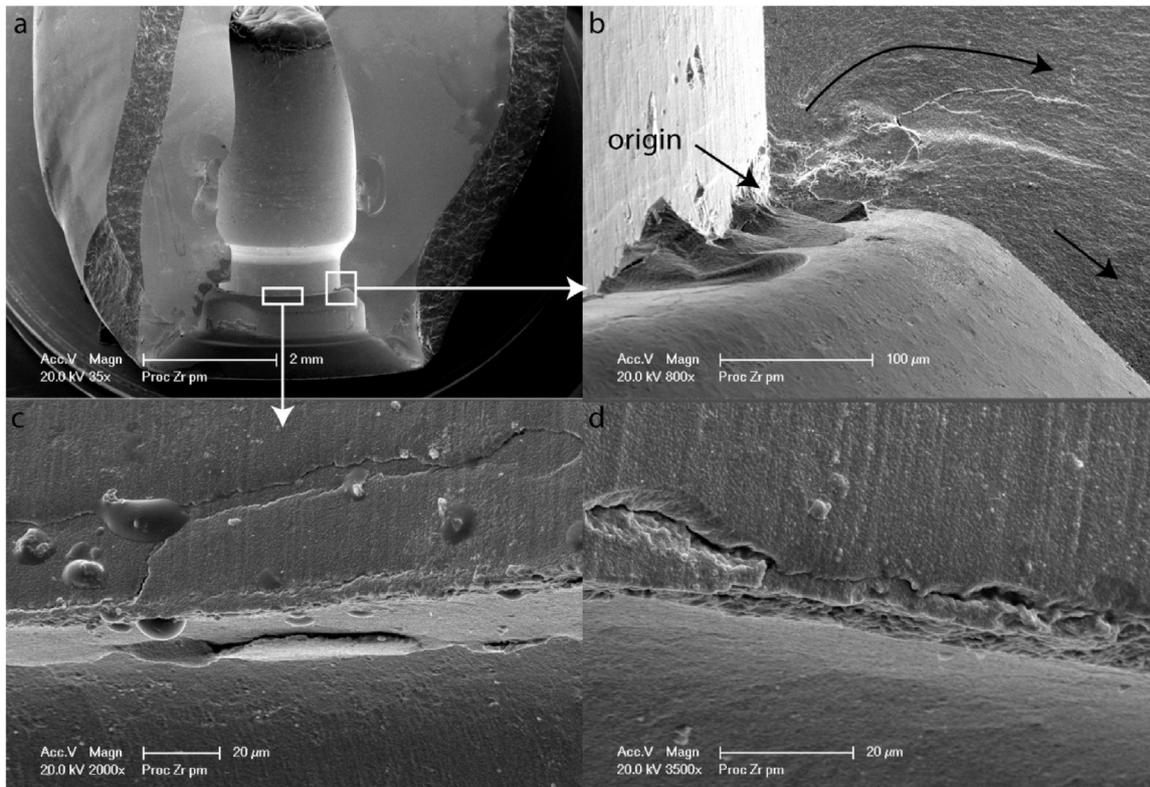
Processing flaws from the manufacturer may be involved in the premature failure of a clinical component. The case presented in Fig. 12 is the same as in Figs. 10 and 11. On the rim connecting the simultaneous developing corner crack origins on both sides (see stereomicroscopy in Fig. 10), a close-up view (Fig. 12c,d) in the area of the central white rectangle shows multiple cracks. Possibly these were introduced during the pre-sintered state machining of the abutment part. This area involves a screw contact and is considered sensitive to damage [25,51]. The manufacturer should therefore have some means to facilitate crack detection in the green state before sintering and packaging the block for sale. Fluorescent penetrant liquids, water-washable and water-based (such as Ardrex® 920A, Chemetall), are used in the aeronautic industry and also for

**Fig. 12** – Same case as described in Figs. 10 and 11. Further SEM analysis of the inner rim show evidence of major precracks spread over the entire length of the rim, thus weakening the structure. These cracks are related to manufacturer processing problems.

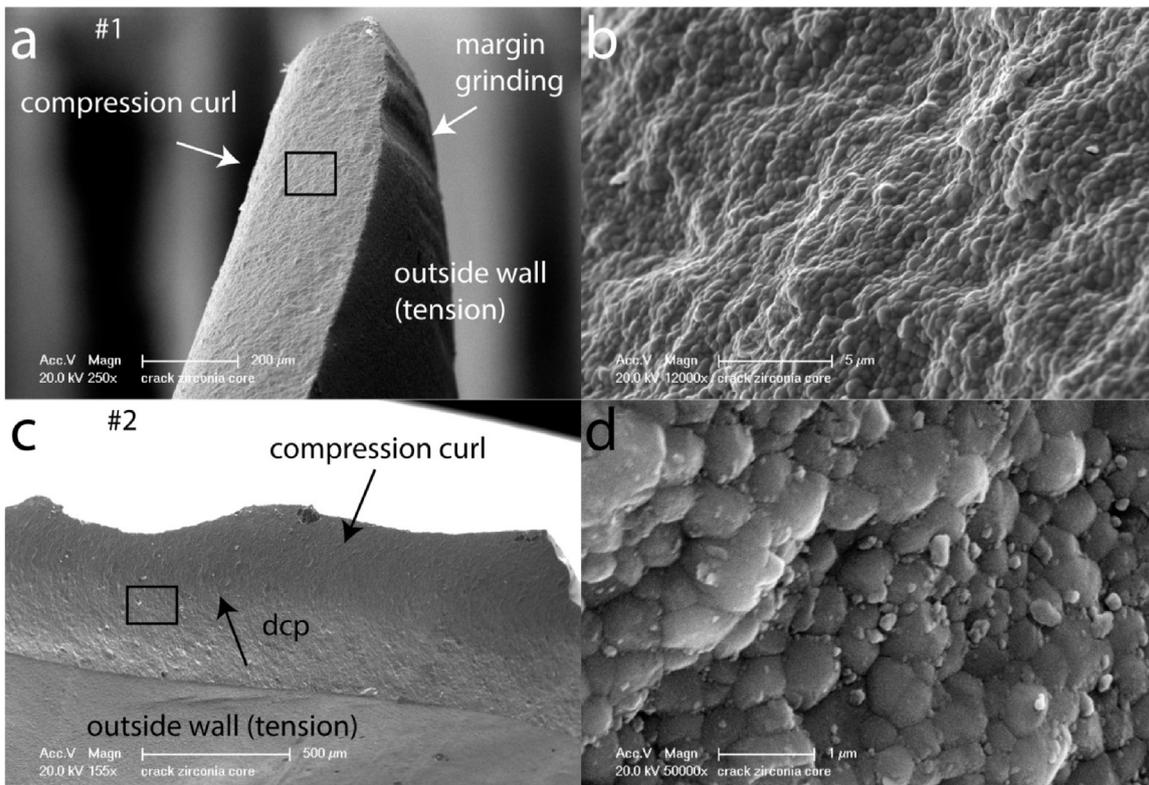
Both parts are seen in Fig. 15 showing the grinding marks on the outer surface near the margin (Fig. 15a). A higher magnification (Fig. 15b, 12,000×) of the grains on that surface (black rectangle) reveal that they are round, which means unconstrained free air sintering. Confirmation is provided with part #2 in which the compression curl is clearly visible on the inner side (Fig. 15c), confirming that the direction of crack propagation (dcp) moved from the outer surface of the framework (where the grinding marks are) towards the intaglio surface. A higher magnification in Fig. 15d (50,000×) shows quite rounded grains from unconstrained sintering due to a crack introduced during green state grinding.

**Fig. 15 – SEM fracture surfaces of both matching sides (#1, #2) of the crack in the zirconia framework illustrated in Fig. 13. Grinding marks are visible on the outer surface near the margin (a). At higher magnification (12,000 $\times$ ) the grains on that surface (black rectangle) can be seen to be round in shape, which means free air sintering (b). Confirmation is provided with part #2 in which the compression curl is clearly visible on the inner side (c) confirming the direction of crack propagation (dcp) moving from the outer surface of the framework (were the grinding marks are) towards the intaglio surface. A higher magnification in (d) (50,000 $\times$ ) shows quite round grains from free air sintering due to a crack introduced during green state grinding.**

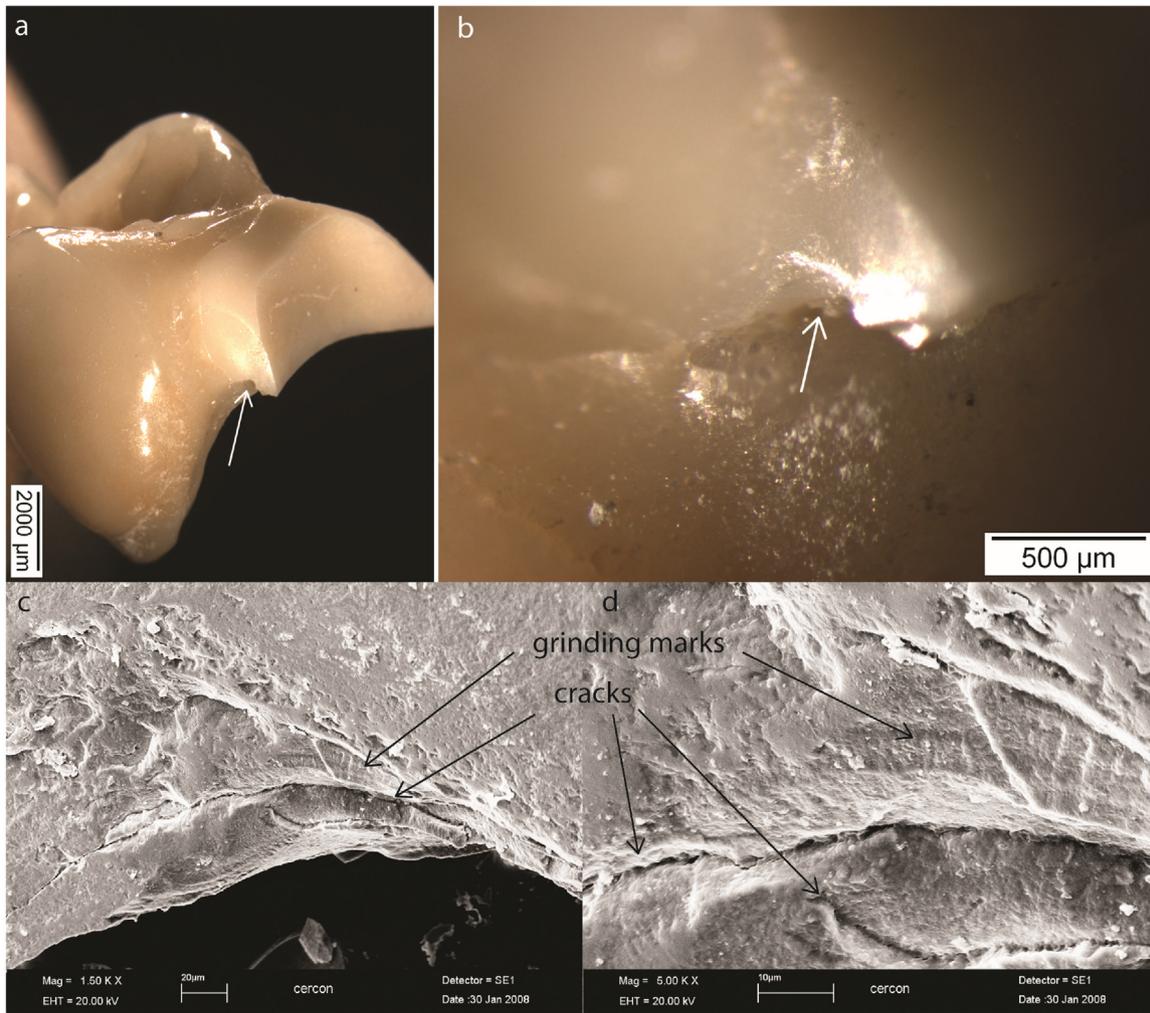
Another example of grinding cracks is shown in Fig. 16, a clinical failure of a zirconia 4-unit bridge after 9 months of intra-oral use. In this instance the embrasure region between

the premolar pontic and the molar abutment crown was reshaped by the dental technician, most certainly to create sufficient space for the papilla. The purpose here is to show the grinding damage in the presintered state at the embrasure region. How do we reach this conclusion without looking at the shape of grains? The answer is given by zooming in with the SEM at that site. A preliminary search for hackle lines moving from the bottom to the top (not shown here) made us focus on the embrasure region (Fig. 16a,b). A closer view (Fig. 16c, 1500×) of the embrasure shows tool marks (little steps) from bur adjustment as well as cracks. Further zooming in with the SEM at 5000× magnification (Fig. 16d) shows horizontally running cracks over 100 µm distance in between the grinding mark. Failure of the cracks to fuse during the sintering process is an indication that the cracks were introduced in the presintered state during framework reshaping by the dental technician possibly to create more space for the papilla.

**Fig. 16** – Clinical fracture of a zirconia 4-unit bridge after 9 months of intra-oral use occurred between the premolar pontic and the molar crown abutment. The embrasure region is marked with a white arrow. Higher magnifications (c,d) show grinding marks from a bur as well as cracks. The partial fusion of these cracks indicates that cracking occurred in the presintered state.

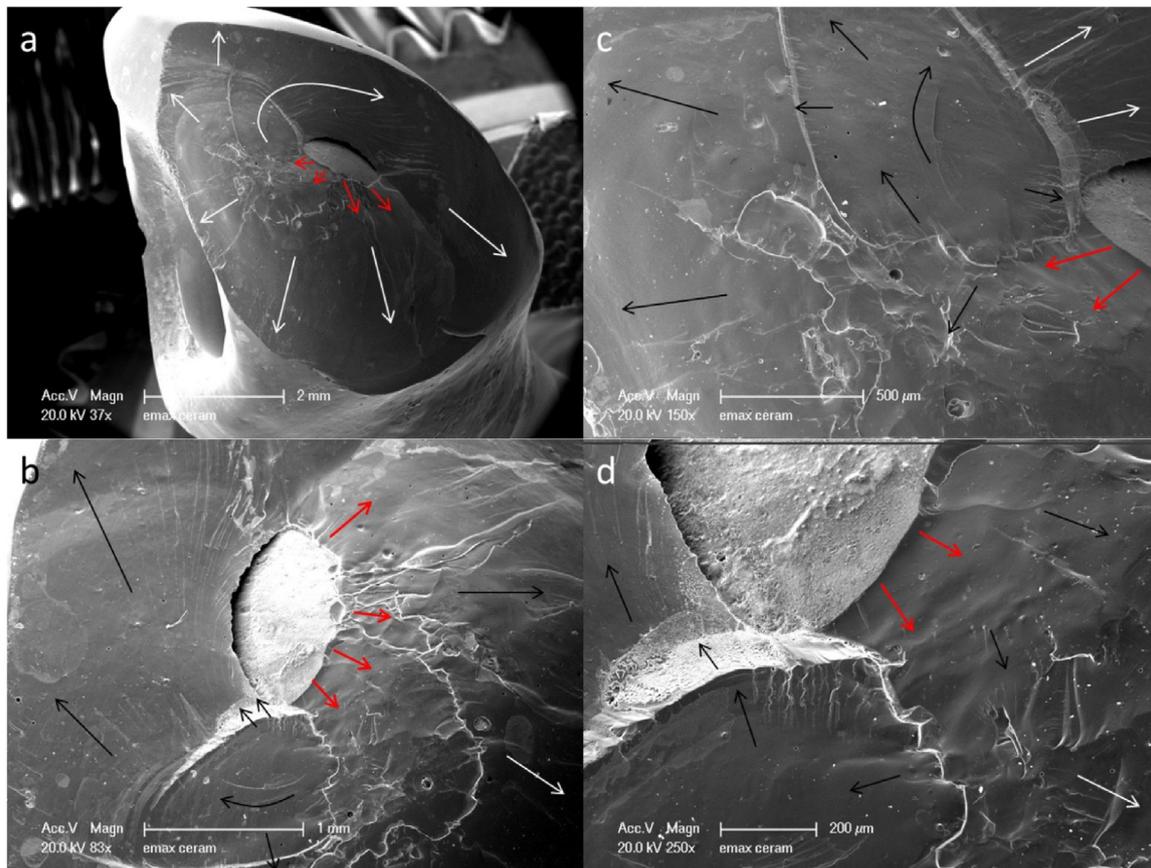
an important ( $0.6 \times 1$  mm) central void between the veneering ceramic and a liner layer over the zirconia core. The crack started from the edge of the pore at the red arrows, radiating outwards and propagating along the white and black arrows with a twist around the pore as confirmed by the presence of fracture surface features (i.e., hackle, wake hackle, twist hackle, arrest lines). The central pore comes from the layering technique entrapping some air and creating a stress state around the pore [54,57]. Thermal residual stresses may have contributed to this early failure even though the dental technician used a compatible veneering ceramic (e.max Ceram, coefficient of thermal expansion  $CTE = 9.5 \cdot 10^{-6}/^{\circ}K$ ) and slow cooling. Thermal stress gradients remain distributed within the veneering ceramic but their magnitude and distribution is complex as so many parameters play a role ( $\Delta CTE$ , firing parameters, veneering ceramic thickness, core-veneering ceramic thickness ratio, zirconia-veneering ceramic interface). In this case, the thickness of the veneering ceramic was quite important ( $\geq 2$  mm). From experimental data, it is known that increasing the thickness ratio of the veneering ceramic to the zirconia core will increase the development of residual tensile stresses [55–58]. Interestingly – in contrast to common believe among dentists – the chipping event occurred completely in the veneering layer without touching the interface. In most fractographic studies, a thin remaining veneer layer was detected on the zirconia interface. This layer presents evidence of residual stresses close to the interface [67–69]. From a clinician's perspective the fracture plane appears whitish

clinical case in Fig. 17. This implant supported central incisor crown, consisting of a 3Y-TZP core and a fluorapatite veneering ceramic, fractured after 2 months of intra-oral use. The fractographic findings point back to a fracture origin being

**Fig. 17 – SEM images of a veneering ceramic fracture after two months involving the zirconia core interface. A void of approximately 1 × 0.5 mm over the zirconia framework covered by a ceramic liner layer was the origin of the crack. The crack started at the red arrows radiating outwards, propagating along the white or black arrows with a twist around the pore as confirmed by the presence of fracture surface features (i.e., hackle, wake hackle, twist hackle, arrest lines). Thermal residual stress may have contributed to this early failure. (For interpretation of the references to color in this figure legend, the reader is referred to the web version of this article.)**

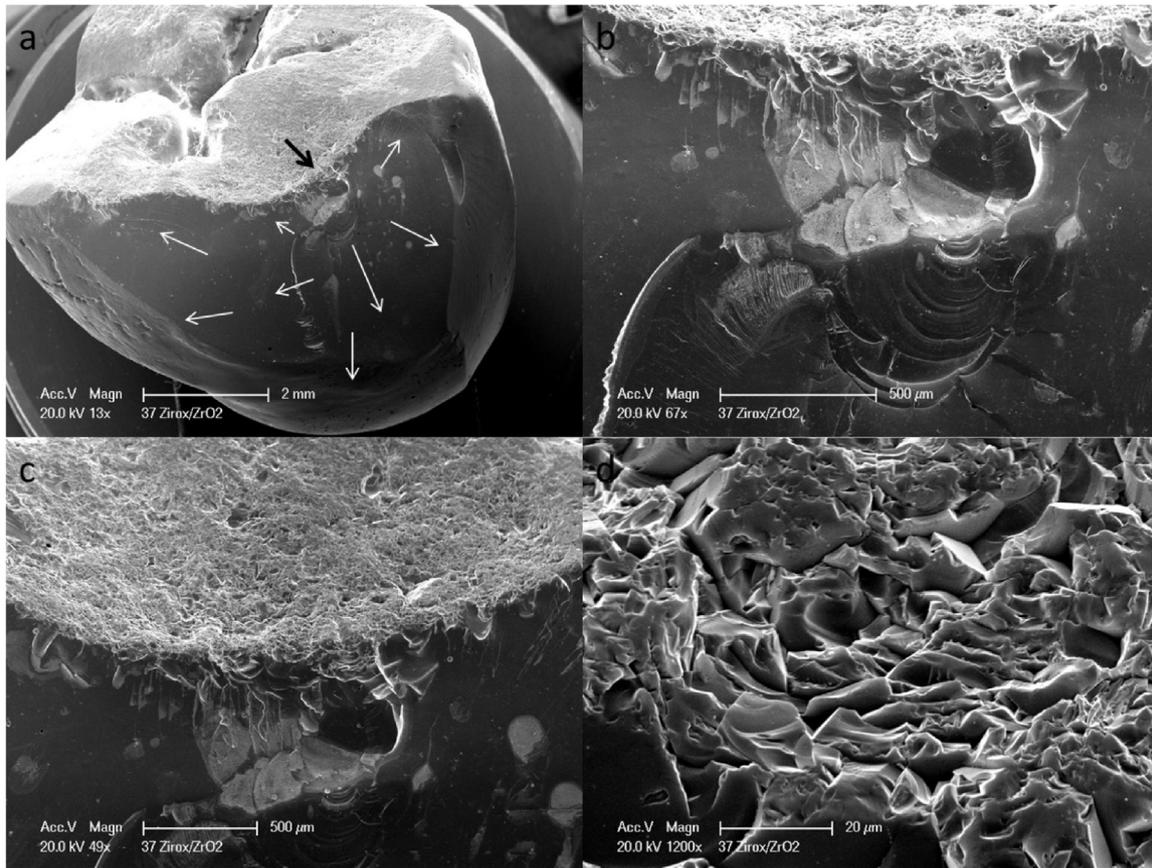
**Fig. 18** – Replica fractographic analysis of a 12 months chip-fracture of a non-leucite veneering ceramic (Zirot) over a zirconia core. (a) Provides an overall image of both the occlusal surface and the fracture surface. The black arrow points to the origin of the chip-fracture. The white arrows indicate the dcp. Further magnifications focus on the fracture origin (b) and the substantial worn occlusal surface (brittle fracture) (c,d) involved in the fracture process.

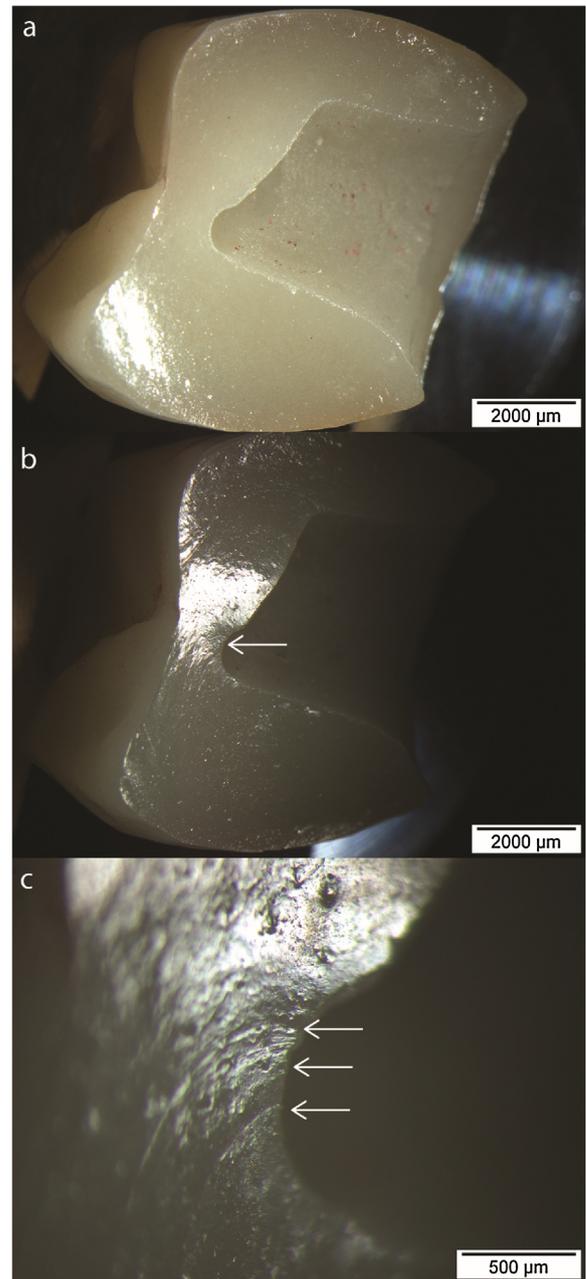
**Fig. 20 – A lithium disilicate try-in failure is documented using a stereomicroscope and lateral illumination. In (a) no fractographic features are visible in the overall image. By changing slightly the angle of light incidence it is possible to make key features to appear very clearly as seen in images (b) and (c). The white arrows indicate the crack origin failure at the inner occlusal corner.**

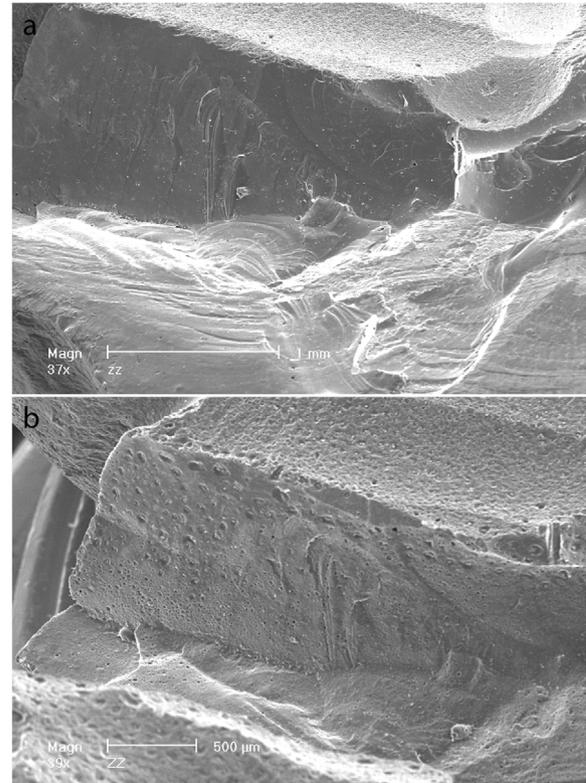
**Fig. 22** – SEM images of a clinical fracture surface of a zirconia veneered bridge with delamination of a portion of the veneering ceramic (a) as well as of a polyether replica poured with epoxy (b) both viewed in the same area. The polyether shows a poor surface reproduction of details due to its chemical incompatibility with the epoxy.

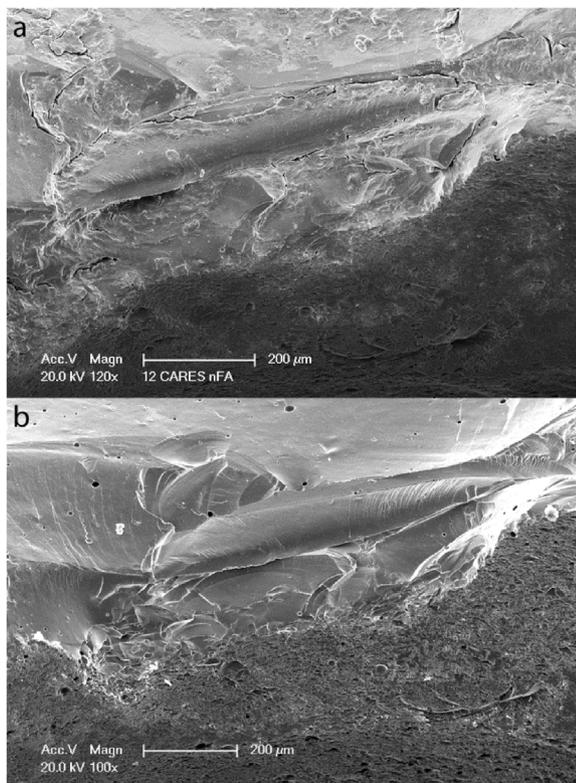
**Fig. 24 – Illustration of a fluorapatite veneering ceramic chip-fracture of a zirconia screw-retained and implant supported single crown. The retrieval occurred a few days after fracture occurred, therefore covered with a thin biofilm. (a) shows the fractured surface after 5 min ultrasonic cleaning in alcohol. Most of the fracture surface features are masked. (b) (100×) shows the same clinical ceramic specimen after 1 min of aqua regia soaking to dissolve the gold coating followed with a 5 min ultrasonic cleaning in 16% NaOCl. The biofilm has been efficiently dissolved and the fracture origin next to a worn occlusal surface is clearly visible.**
