# ADM guidance—Ceramics: guidance to the use of fractography in failure analysis of brittle materials

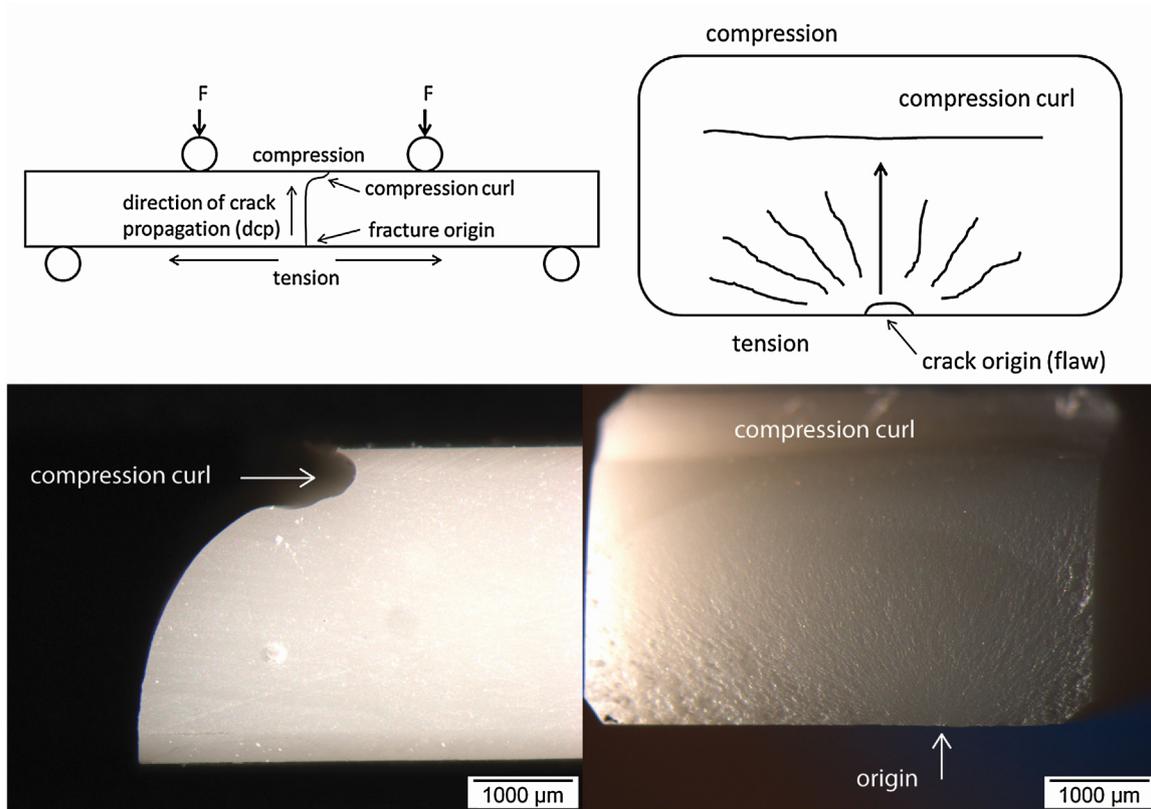
**Fig. 1 – Schematic and illustration of a zirconia bend bar under 4-point flexure test. The fracture origin is to be searched on the tensile side. A compression curl is usually easy to see and will be located at the compression side. The two stereomicroscope images show a side view (left) and fracture surface (right) of the broken zirconia bend bar.**

**Recommendation1: When documenting and identifying critical flaws in strength tests (bend bars, biaxial discs), the fractographic analysis should provide an overall image (Figs. 1–3) of the broken part at low magnification so as to allow clear detection of both the tension and compression sides (signaled by a compression curl), as well as intermediate and high magnification images of the origin (Fig. 2b,c). Photographs should be labelled with the direction of crack propagation (dcp), the origin and all other key fracture surface features (fracture mirror, hackle, wake hackle, twist hackle, arrest lines, compression curl) to confirm the fracture orientation. A view at a slight angle showing simultaneously the fracture surface and the surface in tension is helpful in verifying if the origin is connected to the surface or near surface and if specimen processing (such as grinding, sandblasting) is related to the failure origin (Fig. 3a). The origins, which are of key interest in failure analyses, should also be photographed at high magnification (Figs. 2c and 3) in order to allow discussions regarding the type of flaw that was responsible for fracture.**

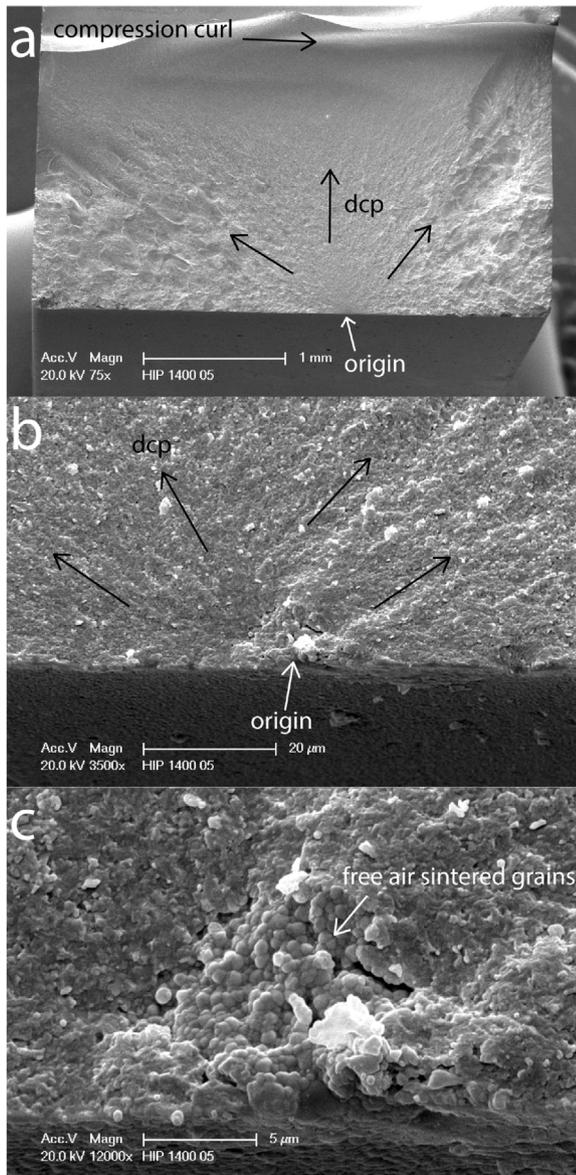
Similar porous regions, as shown in Figs. 2c and 3 bc, are the result of interstices or pores remaining between agglomerates that underwent poor deformation during powder compaction. Zirconia grains that sintered freely in air (i.e. unconstrained sinter conditions) will have round shaped grains versus a more

**Fig. 2** – Standard documentation of a bend-bar strength-test failure. On the overview (a), the orientation of the specimen is labeled (compression curl on top), the direction of crack propagation (dcp), the origin (on the tensile side, bottom). The close-ups (b,c) of the origin should provide enough details with respect to volume, near-surface or surface generated flaws. (c) taken at 12,000 $\times$  magnification shows the origin being a porous region ( $\sim 10 \times 10 \mu\text{m}$ ) between agglomerates during compaction. The zirconia grains are free air sintered as seen from shape of the grains which are round versus the more angulated grains on the bulk fractured surface as a result of inter or transgranular fracture (data from Ref. [35]).

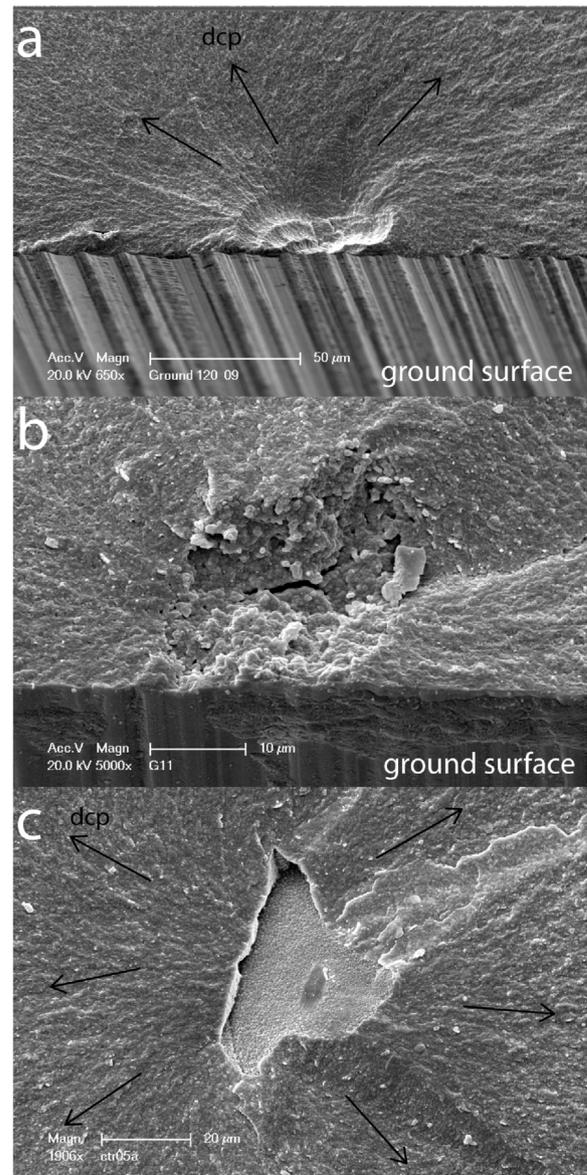
**Fig. 3** – Critical flaws representing failure origins in lab-scale tested 3 Y-TZP bend bars. (a) shows a surface flaw from rough ( $120 \mu\text{m}$ ) grinding on the tensile side of a specimen. Black arrows indicate the dcp based on fine hackle radiating outward; (b) shows a surface connecting origin of a porous region ( $20 \times 25 \mu\text{m}$ ) related to pressing powder agglomerates. Inside the porous region, the grains are free-air sintered (round); (c) shows a volume located origin from a large void defect between agglomerates or granules from powder pressing. The center of the defect shows again free sintered grains. Hackle are radiating from this pore outwards and indicated by black arrows for the dcp. All these defects are representative of processing issues (data from Ref. [35]).

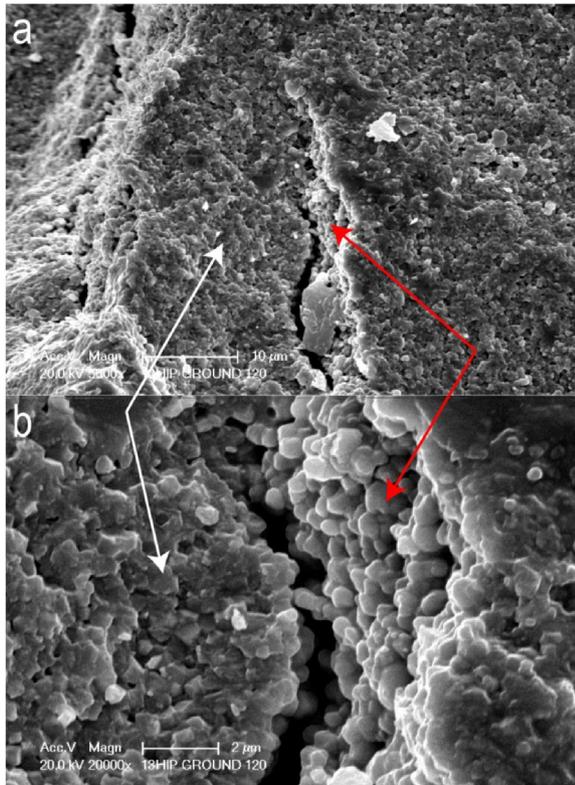
angulated grain shape seen on the bulk fractured surface as a result of inter or transgranular fracture. The shape of the grains (round versus angled) may serve as a diagnostic tool during failure analysis and thus understand if the defect was introduced before or post sintering. An example is given in

Fig. 4, which shows grinding cracks introduced in a zirconia bend bar in the presintered state. Later in this paper, grinding cracks in the presintered state resulting from reshaping zirconia CAD-CAM framework will be shown (Figs. 14 and 15).

**Fig. 4 – Fractured surface of a zirconia bend bar. The free-air sintered grains (within a fissure space) are round-shaped (red arrows) whereas the grains on a bulk fractured surface post-sintering are angulated in shape as a result of transgranular or intergranular fracture.**

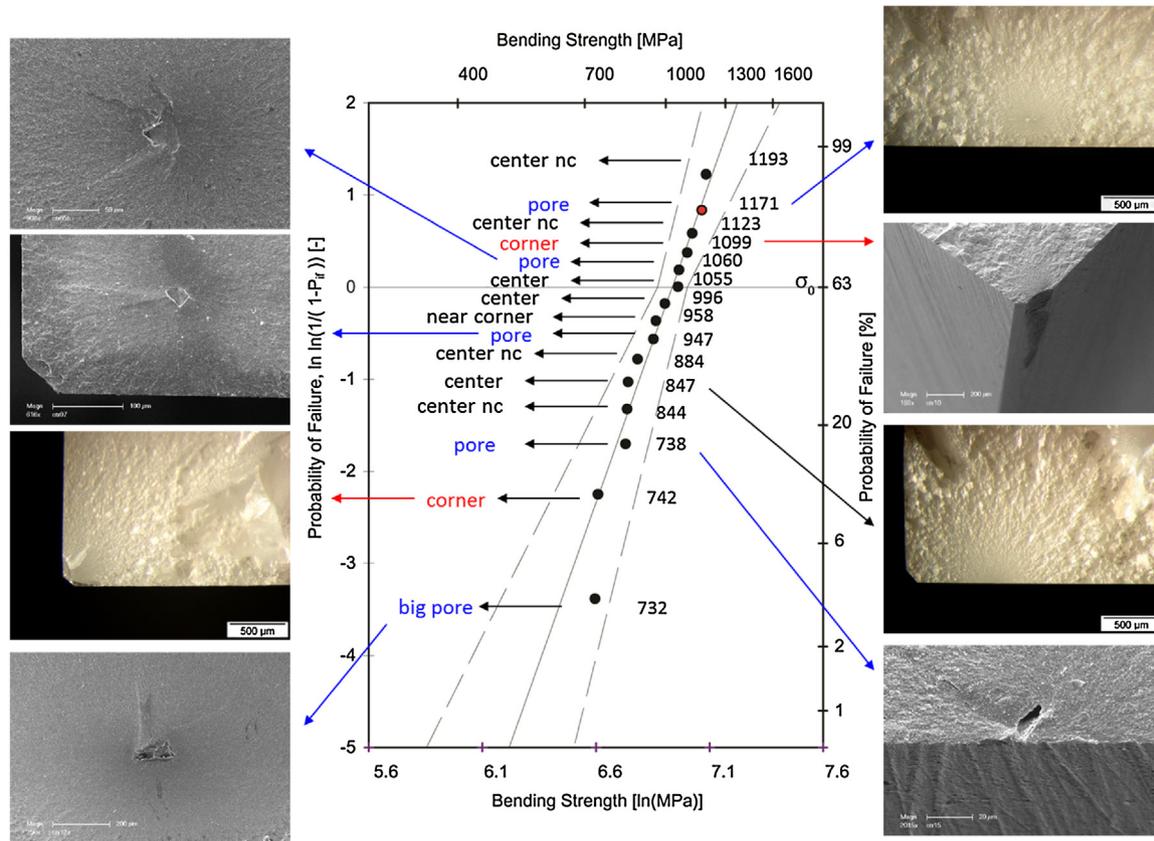
two parameter distribution contains a scale ( $\sigma_0$ ) and a shape parameter (Weibull modulus,  $m$ ). The scale parameter is called the characteristic strength  $\sigma_0$  and corresponds to the 63.2% failure probability (see Fig. 5) whereas the Weibull modulus  $m$  indicates the homogeneity of the strength data, thus expressing reliability. A Weibull modulus in the range between 10 and 40 is related to ceramic materials with less variation during strength testing, i.e., a narrow flaw population and overall improved quality. A low  $m$  (between 1 and 10) means a wide distribution, large spread and low reliability, which requires improvement and thus a closer look at the reasons for failure. Generally speaking, increases in strength and reliability will come from a significant reduction in the critical flaw size by means of improvements made to the processing methods. A thorough and practical review of the Weibull analysis illustrating the importance of flaw size distributions when using different test configurations has been published by Quinn and Quinn [36]. The authors analyzed every single specimen and identified different failure mechanisms leading to clustered flaw populations. An important prerequisite for a thorough Weibull analysis is a sufficient number of specimens. A sound analysis is based on thirty or more samples in a group (EN 843-5). What is very helpful in the data analysis is to present a fractography montage in conjunction with a Weibull strength graph [1,8,37], or to follow-up with SEM fractographic analysis to show the type of flaws encountered during strength testing [38–41]. Overlooking the step of identification of the critical flaw population may lead to wrong conclusions when comparing reliability data between materials or when claiming that one ceramic is significantly stronger or weaker than another without understanding the causes of fracture. An example of a fractographic montage is given in Fig. 5.

**Fig. 5** – Example of a fractographic montage superimposed on a Weibull strength distribution with confidence intervals of 3Y-TZP bend bars. Failure origins of selected specimens within the Weibull distribution are shown in stereo and SEM images. Fracture origins are sintering pores and grinding damages, flaws at corners or near corners (nc) or pores located in the volume or near the surface resulting from the compaction process. The Weibull  $\sigma_0 = 1028$  (963–1099) MPa shows a mix of specimen preparation problems and intrinsic processing defects, which contribute to a rather low reliability, as indicated by the  $m$  value of 6.97 (4.9–10.0) (data from Ref. [35]).

**NB:** Weibull estimates should be performed on a minimum of 30 strength data which was not the case in this example.

**Recommendation 2:** Fractographically identified fracture origins are marked on the Weibull strength distribution plot (Fig. 5) or on a fatigue S–N curve (Fig. 6). Hence, the flaws responsible for failure can be differentiated between intrinsic to the ceramic (sintering pores, voids from compaction of granules or agglomerates, inclusions, impurities, etc.) or related to sample preparation (grinding, specimen preparation) and testing issues (Figs. 2 and 3). The weakest specimens should be analyzed with great interest as they represent early failures at stresses at the lower end of the distribution. Their critical flaws should be compared with those of the high strength specimens.

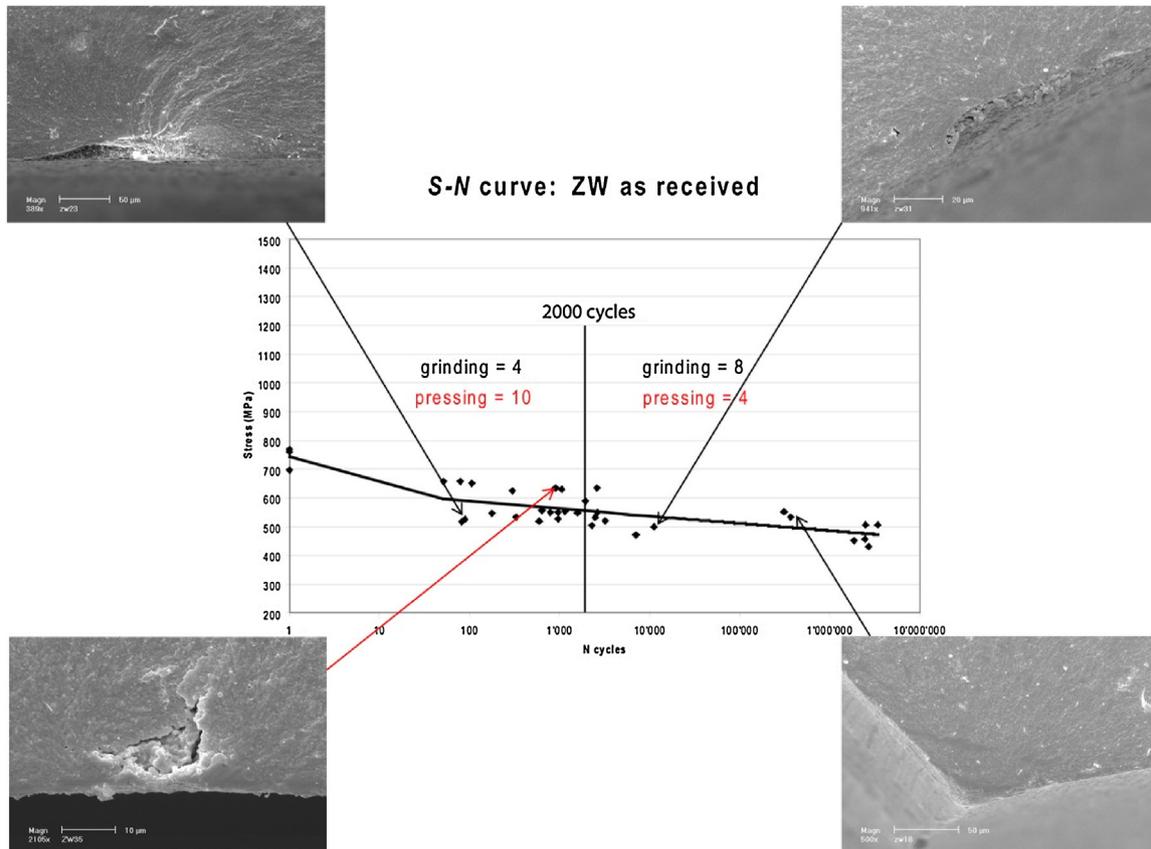
Similarly to strength specimens, fatigue tested specimens should also be fractographically analyzed for critical flaw assessment. The type of flaw (ceramic processing or surface induced) can be labeled directly on the S–N plot (Fig. 6) and selected fractographic images of the critical flaws discussed to explain the findings. The early and high stress cycles may activate a different population of flaws compared to that activated in specimens cycled for longer times. In a S–N (Wöhler) fatigue study on 3Y-TZP [42], S–N data showed that processing defects (pressing of powder granules) were primarily activated under conditions of high stress/low cycle (<2000) fatigue, whereas the grinding surface flaws were the dominant ones when subjected to low stress/high cycle (from 2000 to  $10^6$ ) fatigue. Of course the location, size and shape of the critical flaw, whether intrinsic or from grinding, have to be considered, as well as the stress level and loading direction.

**Fig. 6** – Example of fractographically labelled S–N data. Failure origins of selected specimens within the fatigue test are shown by SEM images. Location of fracture origins in bend bars are flaws from pressing, grinding or corner cracks (data from Ref. [42]). The red arrow is for a pressing defect on the S–N data points. (For interpretation of the references to color in this figure legend, the reader is referred to the web version of this article.)

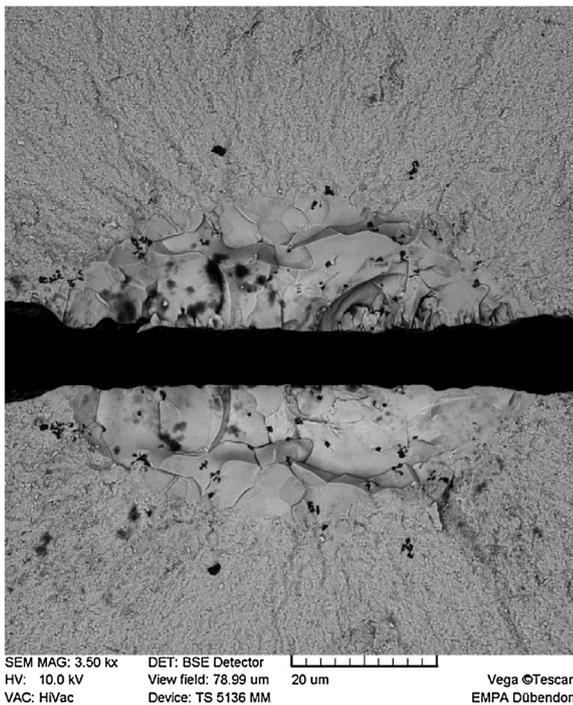
By using the backscattering mode in the SEM, it becomes often possible to highlight structure features and distinguish different phases, which can complement a first SEM image. As an example, Fig. 8 shows another zirconia specimen of the same research [35] with a failure origin from excessive grain growth similar to that seen in Fig. 7. The backscattering mode at  $3500\times$  reveals many large grains forming one large critical flaw activated during 4 point-bending. For this particular specimen, the fracture stress  $\sigma_f$  was  $586 \text{ MPa}$ , the measured critical flaw depth  $a = 20 \mu\text{m}$  and width  $2c = 60 \mu\text{m}$ , the calculated  $Y_{\text{depth}} = 1.42$  using Scherrer et al. [48]. Based on Eq. (1), the calculated  $K_{\text{IC}}$  was  $3.7 \text{ MPa}\sqrt{\text{m}}$ . One explanation for such low toughness may be the additional processing step of post sintering Hot Isostatic Pressing (post-HIP) performed at  $1400^\circ\text{C}$

**Fig. 8 – Backscatter viewing mode of a critical flaw made of excessive grain growth in a 3Y-TZP after post-sintering HIP and 4-point bending strength test.**

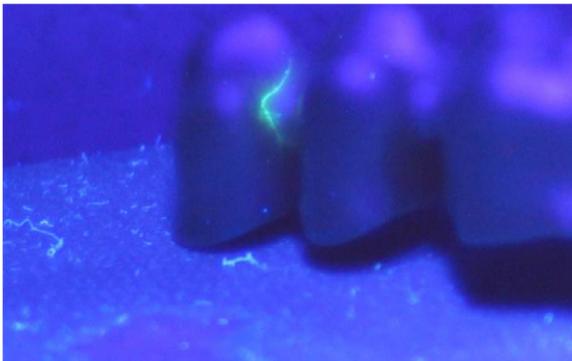
zirconia to reveal cracks as the fluorescent liquid penetrates any crack and shines in a UV chamber. An example of such non-destructive quality control performed by manufacturers is shown in Fig. 13. These cracks cannot be repaired and this piece is to be discarded in order to avoid a useless sintering process and valuable working time loss. Other methods for crack detection have been evaluated for dental ceramics using light microscopy, SEM and fluorescence microscopy [52], the latter being the most efficient crack detecting method. Overall, more quality control should be performed both at the manufacturer and dental technician level when working with brittle materials in which microcracks can be introduced during the processing steps. Zirconia frameworks should all undergo at least a transillumination screening test after sintering (Fig. 14) before applying the veneering ceramic.

**Fig. 13** – Zirconia green body framework dipped in Ardrex® 920A, a water-washable and water-based fluorescence liquid, revealing a crack in a UV chamber (image courtesy of Diadem, F).

**Recommendation 5:** When zirconia fractured parts are available such as abutments, implant or, bridge frameworks involving connectors, one should search for additional processing issues such as sintering problems, compaction, and presintered state grinding induced cracks.

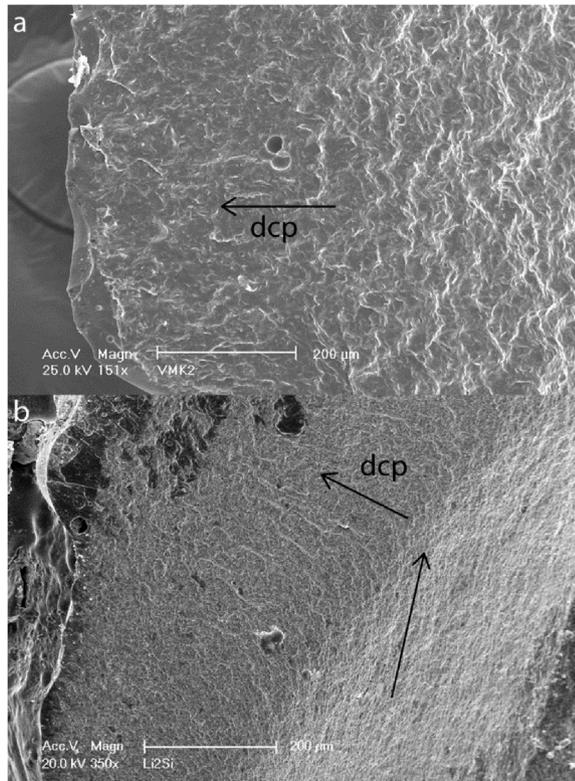
features such as a compression curl or arrest lines over the entire part. The lithium disilicate has a smoother fracture surface compared to the feldspar-based ceramic but has a very dense structure and usually there are little to no pores to rely on for the dcp identification. In the image in Fig. 19b a careful observation in the SEM allows one to distinguish many hackle lines running parallel to each other over the entire cracked surface. In such cases it is even more important to spend time with the stereomicroscope and use lateral illumination to bring out crack features at low magnification before going to the SEM. This is particularly true for lithium disilicate glass ceramics. An example of how a slight change of light angulation in the stereomicroscope can highlight key crack features such as hackle, wake hackle, Wallner lines is shown in Fig. 20. A lithium disilicate crown broke during a try-in over a titanium abutment. The inner occlusal corner was the crack origin at

**Fig. 19 – A fractured surface of a feldspar-based ceramic (Vita Mark II) (a) and of a lithium disilicate glass-ceramic (b) is shown. Both are considered as rather difficult for identification of fractographic surface crack features and determination of the direction of crack propagation (dcp).**

**Recommendation 9:** Be aware of the microstructural differences of ceramics which will render the fractographic analysis more or less complex. If a glassy veneering ceramic is present it will greatly help visualize fractographic features. Use lateral illumination (grazing angle) in a stereomicroscope to visualize (bring out) features with ceramics that are more complex (i.e., Lithium disilicate, feldspathic porcelain).

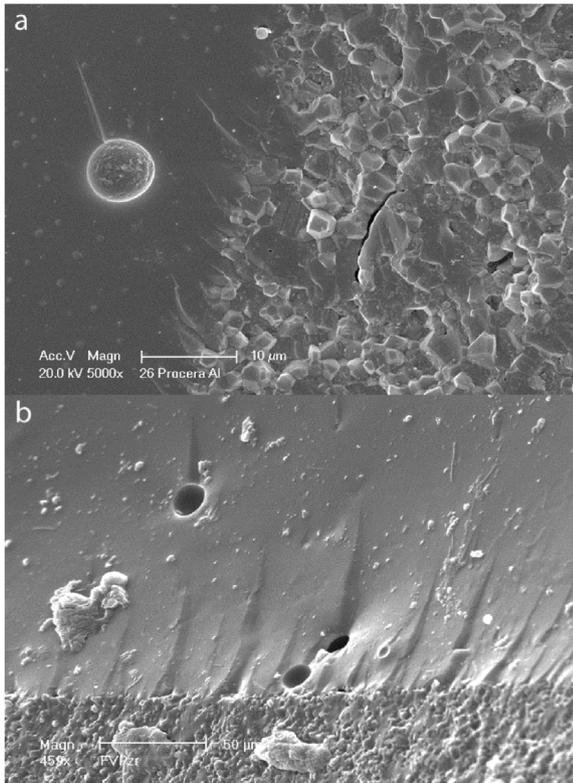
**Fig. 21** – Alumina core (a) and zirconia core (b) with their respective veneering ceramics. The veneering ceramic in both cases show easy recognizable features such as wake hackle, hackle and twist hackle visible at the interface as a continuation of the crack front moving from the core materials towards the veneering ceramic.

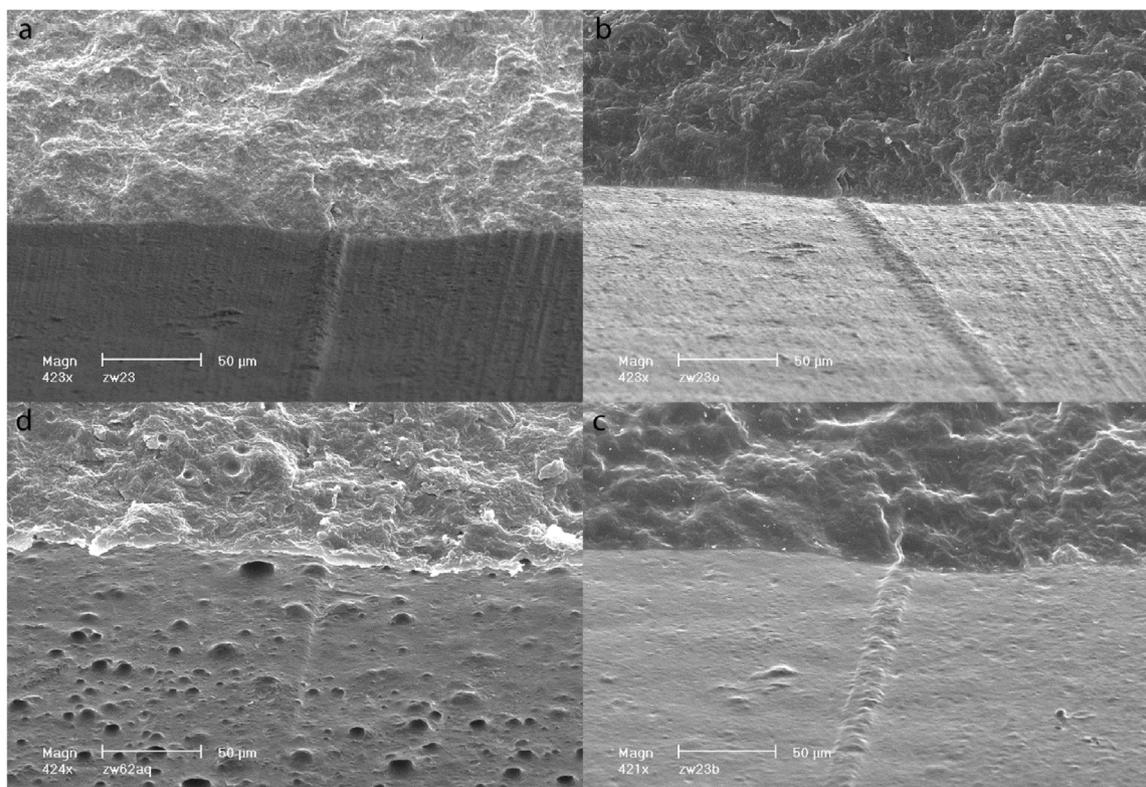
light body) is illustrated for a zirconia bend bar fracture surface. Fig. 23 shows the original fractured zirconia surface, Fig. 23b is the epoxy reproduction of an ultralight body PVS (Express 2, 3M) replica, Fig. 23c of a light body PVS (Express 2, 3M). The degree of detail with the light body PVS impression materials is not as good as with the ultralight body. Some silicone impression materials will however degas as a reaction of Hydrogen release from the silicon and are therefore not suit-

able for fractographic analysis as many air bubbles will appear on the epoxy-poured replica as shown in Fig. 23d (Aquasil PVS, Dentsply).

**Fig. 23** – Illustration of a detail reproduction from an original zirconia broken surface (a) and an ultralight body PVS (Express 2, 3 M) (b), a light body PVS (Express 2, 3 M) (c). Hydrogen release is shown in (d), after pouring epoxy in a light body PVS (Aquasil, Dentsply).

**Recommendation 10:** *Optimum reproduction of detail is obtained when using replicas with a very low viscosity such as an ultralight body silicone impression material. Tests of pouring epoxy and checking the degree of Hydrogen release (degassing) should be carried out before deciding which silicone impression material to use.*
